Panda Tire & Auto

2009 Mazda 6 (BREJ555)

VEHICLE CONDITION REPORT (FEBRUARY 19, 2016)

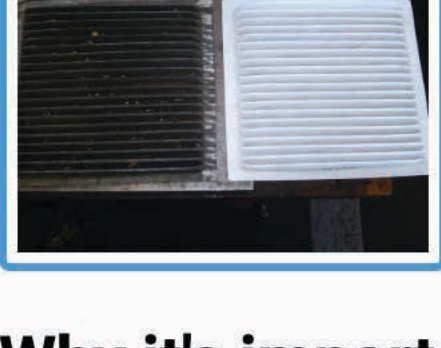
Cabin/pollen air filter

Finding: Cabin air filter dirty

Reason for recommendation: Part no longer performs intended function

Recommendation: Replace filter

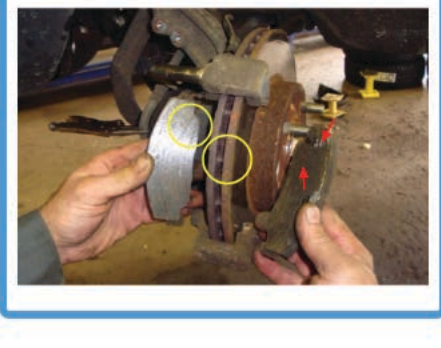
Front pads

Finding: Front brake pads at service limit

Reason for recommendation: Part no longer performs intended function

Driver side brake pads: 2 mm

Passenger side brake pads: 1 mm

Recommendation: Replace front brake pads

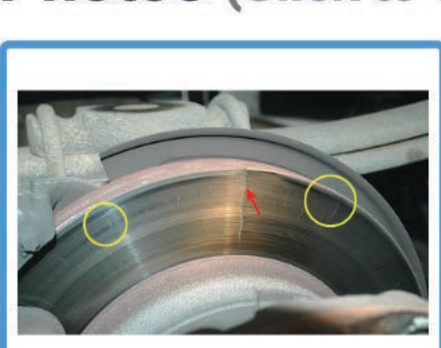
Front rotors

Finding: Cracked

Reason for recommendation: Part does not meet design or specification

Driver side brake rotors: more than 15mm

Passenger side brake rotors: more than 15mm

Recommendation: Replace front brake rotors

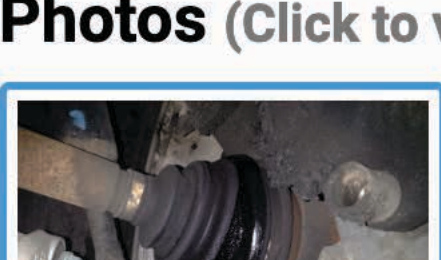
CV drive axle boots

Finding: Ripped/leaking

Reason for recommendation: Part no longer performs intended function

Recommendation: Replace

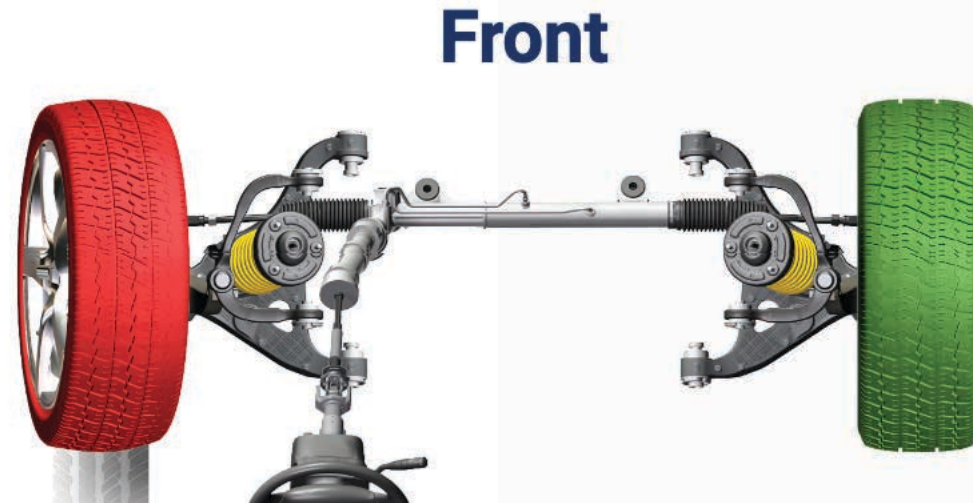
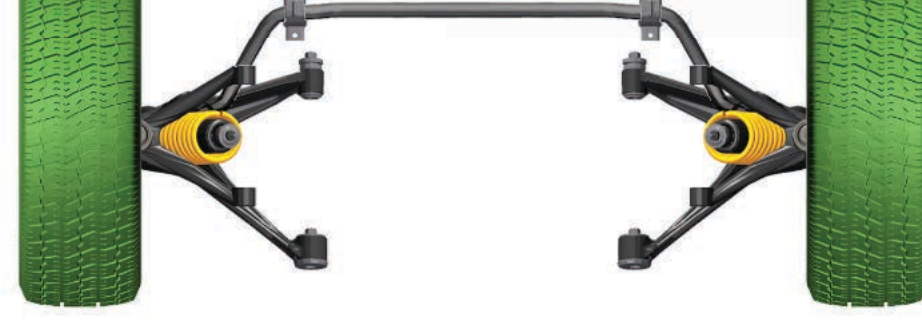
Wheel alignment

Finding: Out of manufacturer's specification

Reason for recommendation: Part does not meet design or specification

Recommendation: Perform comprehensive alignment inspection
